Report on the Mine Clearing Rake Test

October 2006

Prepared by
Institute for Defense Analyses
4850 Mark Center Drive
Alexandria, VA 22311-1882

Operational Evaluation Test Report on the Mine Clearing Rake

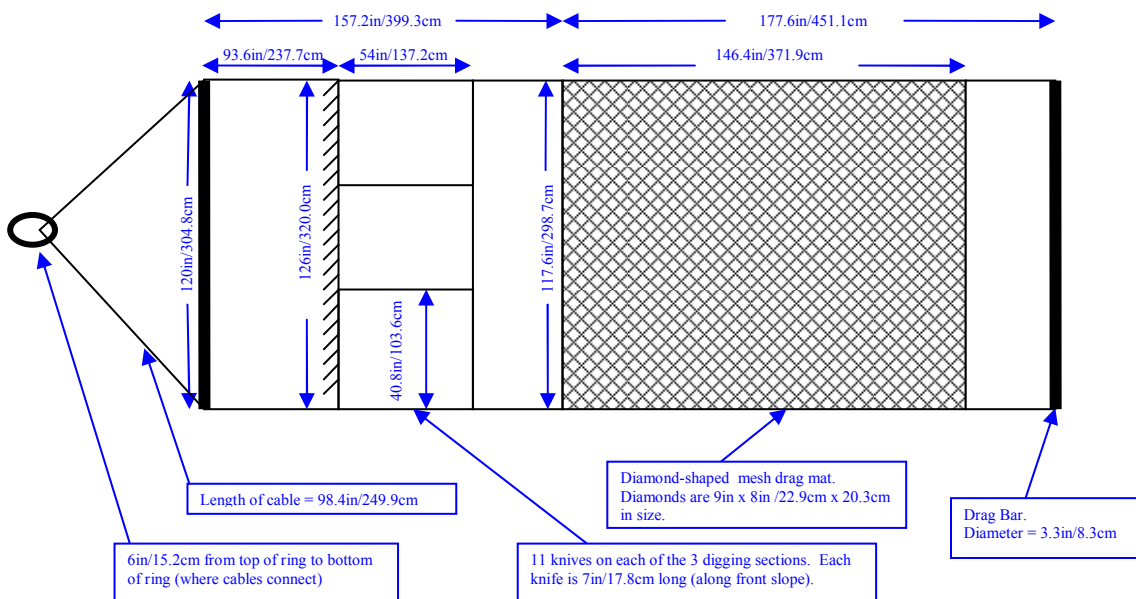
The MCR is comprised of three digging knife units and a drag mat/chain harrow. The MCR, as tested, is shown in Figure 1. This configuration, with the digging knives in a straight line across the front of the MCR, was selected during familiarization runs with the MCR as the one offering the best MCR performance and control of the

Figure 1. Mine Clearing Rake (MCR)

MCR while towing and turning. The tools used in the MCR test were a Fendt 918 Vario tractor (Figure 2), a Loftness 918 Timber Ax Extreme vegetation cutter (Figure 3), a Krause 4830-730F Chisel Plow (Figure 4), an Unverferth Perfecta II Spring Cultivator (Figure 5), and the MCR (Figure 6).

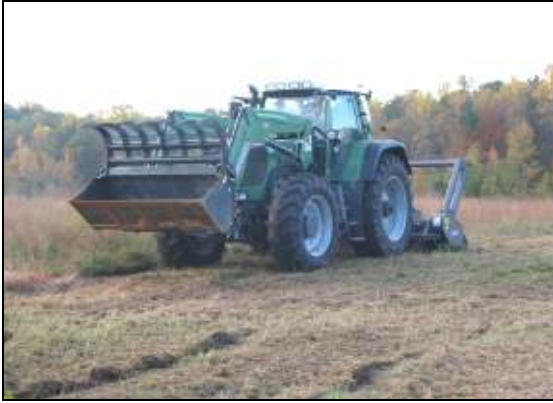
Figure 2. Fendt 918 Tractor

Table 1. Fendt 918 Vario Tractor

Item	Measurement / Dimension
Max Height, to top of cab	10.15/3095 ft/mm
Min Working Clearances under axles	1.98/605 ft/mm
Max Width	8.17/2490 ft/mm
Max Length	16.2/4938 ft/mm
Max Shipping Weight	17945/8138 lbs/kg
Fuel Capacity	530 liters
Oil Capacity	24 liters
Hydraulic Fluid Capacity	65 liters

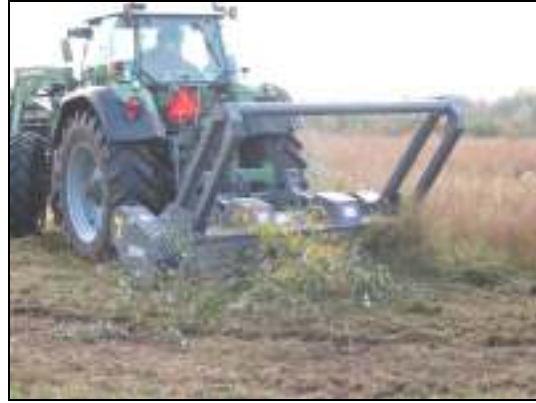
Figure 3. Loftness Vegetation Cutter

Table 3. Loftness Vegetation Cutter

Item	Measurement / Dimension
Width	117/2972 in/mm
Cutter Fielded Weight	4980/2259 lbs/kg
Width of Cut	93/2362 in/mm
Number of Knives	20

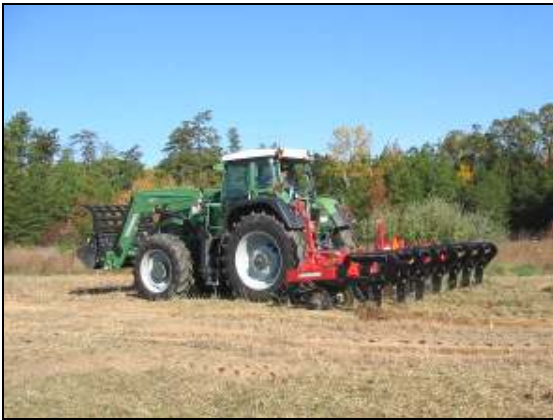
Figure 4. Krause Chisel Plow

Table 4. Krause Chisel Plow

Item	Measurement / Dimension
Width	210/5334 in/mm
Plow Shipping Weight	5364/2433 lbs/kg
Number of Shanks	7
Row Spacing	30/762 in/mm

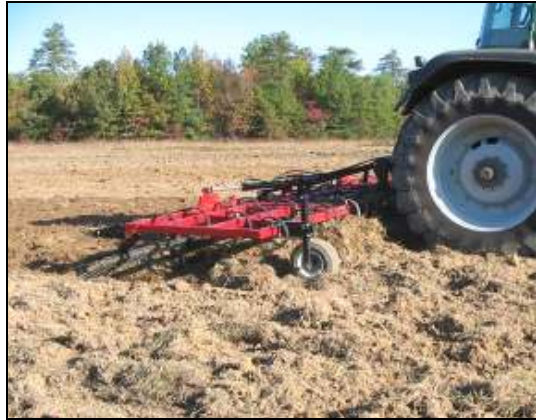
Figure 5. Unverferth Spring Cultivator

Table 5. Unverferth Spring Cultivator

Item	Measurement / Dimension
Width (collapsed)	150/3810 in/mm
Width (extended)	240/6096 in/mm
Folded Height	87/2210 in/mm
Cultivator Fielded Weight	2545/1154.4 lbs/kg
Number of S-Tines	37
Number of Leveling Bar Teeth	40

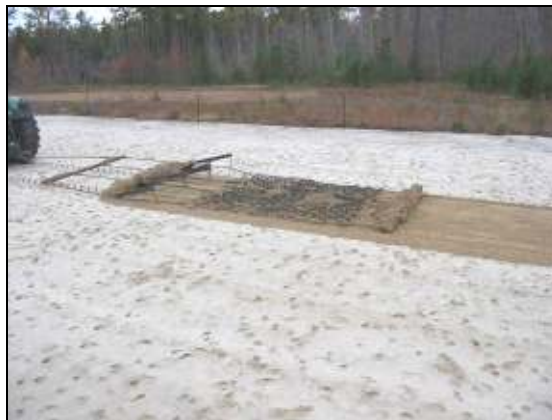
Figure 6. MCR

Table 2. Mine Clearing Rake

Item	Measurement / Dimension
Length (overall)	334.8/8504 in/mm
Width (overall)	125.5/3188 in/mm
Mine Lifting Knife Sections/Width	125.5/3188 in/mm
Number of Knives per Section	11
Knife Length	7/177.8 in/mm
Harrow Grid	8x9 / 203x229 in/mm
MCR Fielded Weight	/ lbs/kg

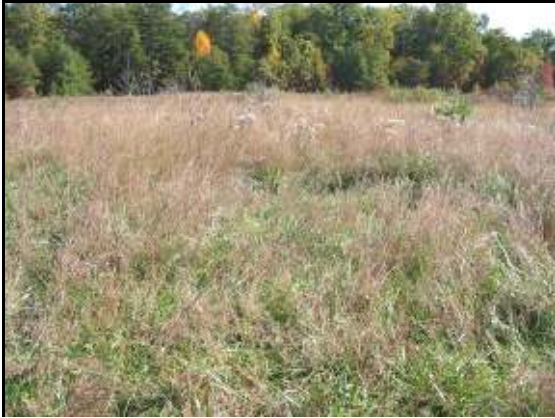
Figure 7. Unprepared Test Site 1

Test Site 1 (141m x 70m) allowed 25 - 30 meters at each end for 180° turns with the MCR between successive passes over the test area. While the vegetation in the total 141m x 70m area was cut with the Loftness vegetation cutter, only the central 70m x 70m MCR test area was plowed and cultivated prior to testing the MCR. Photos of the area preparation process of the first test site are presented in Figures 7 through 12. By the time the test site was considered ready for MCR testing, the test site surface was primarily powdered loam, free of surface grass and shrubs, ready for crop planting. However, the soil still contained pieces of shredded grass and root systems mixed into the soil by the plow and cultivator.

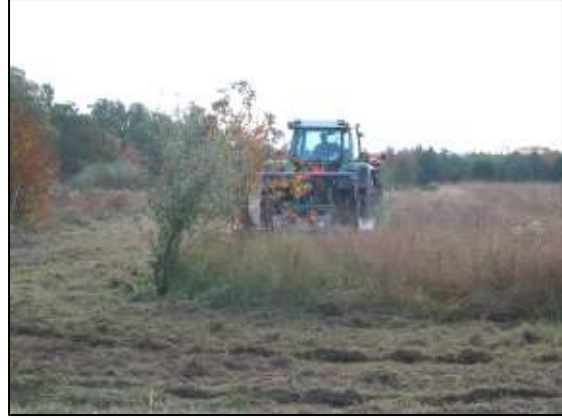
Figure 8. Vegetation Cutting

Mowing of the 135m x 70m area took 2 hours 10 minutes. Average mowing speed was 1.5 mph (2.5 kph). Plowing the MCR test area (75m x 70m) took 3 hours 4 minutes until the soil was judged to be sufficiently broken up to be ready for working with the spring cultivator. Plowing speeds ranged from very slow to a maximum of 5 mph (8.3 kph). The MCR test area was worked with the spring cultivator for 3 hours 21 minutes to insure that the test area was free clumps of sod at speeds of 1.5 to 5 mph (2.5 to 8.3 kph). At this point in the preparation process, the test area resembled mine-cleared areas ready for final quality assurance testing. Figure 16 shows the prepared Test Site 1 field.

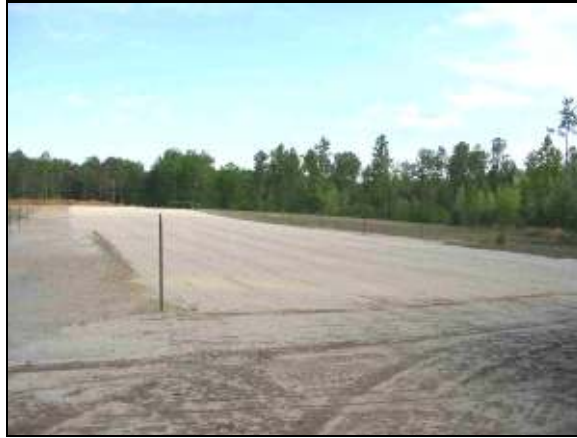
Figure 13. Test Site 2 (Sand Test Site)

There was no need for any preparation of the sand test area (see Figure 13).

Test Site 2, the sand soil test area, required no preparation before MCR testing. While there was spotty evidence of wild grass seed having germinated in the sand, the lack of nutrients in the sand caused the grass shoots to quickly die.

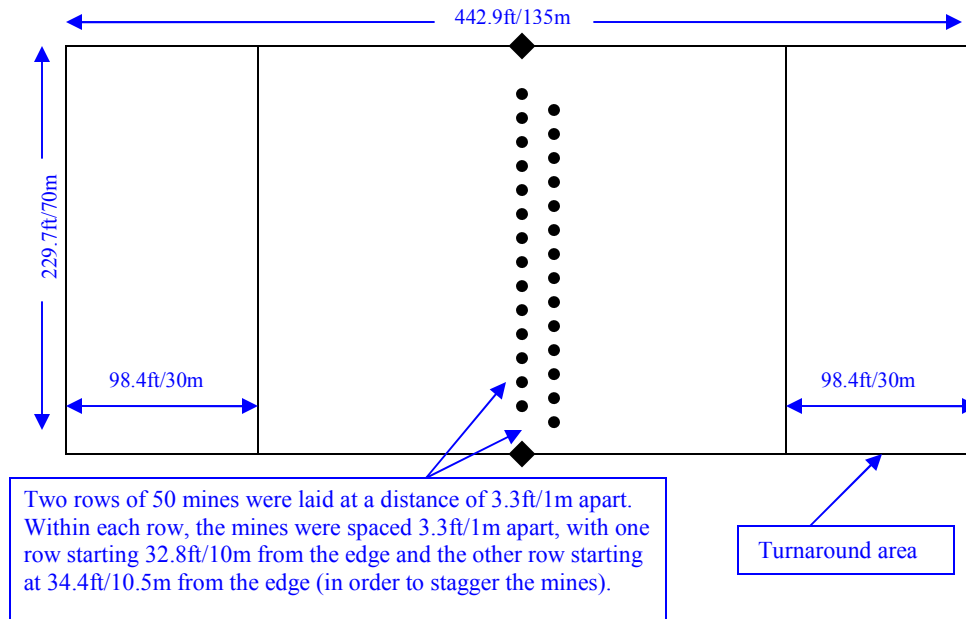
A total of 100 test mines were buried in the center of the Test Site 1 before any area preparation (cutting, plowing, cultivating) was done. The mines were buried at a depth of 5cm to the top of each mine, with 50 mines at 1m intervals in each of two staggered rows. There was a 1m separation between the rows. There was a 10m unmined area between the end of each row and the sides of the test area. All mines were models of actual AP mines. The types and numbers of each mine were:

Figure 14. Layout of Test Site 1 Showing Mine Location and Pattern

A drawing of Test Site 1 area is shown in Figure 14. The area devoted to the actual test of the MCR was 75m x 70m, with 30m at each end set aside to allow adequate room to perform 180° turns without tipping the MCR between successive passes through the prepared test area.

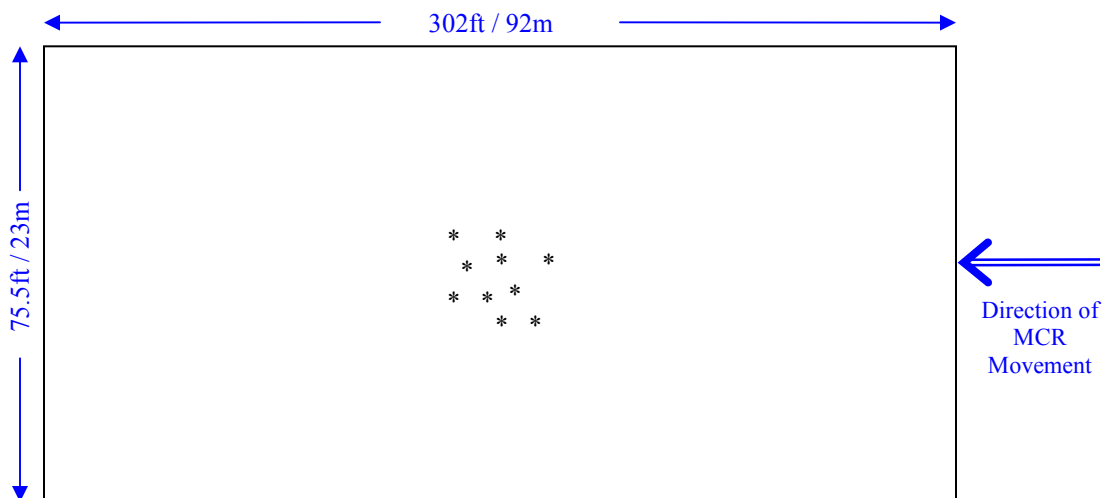
At Test Site 2, the sand site, ten mines were buried. These mines were of the same size and type as those used in Test Site 1. The mines were buried in a scattered pattern along a 1.5m strip in the center of the field to a depth of 5cm to the top of the mine. A layout of the Test Site 2 is shown in Figure 15.

Figure 15. Layout of Test Site 2 Showing Mine Location and Pattern

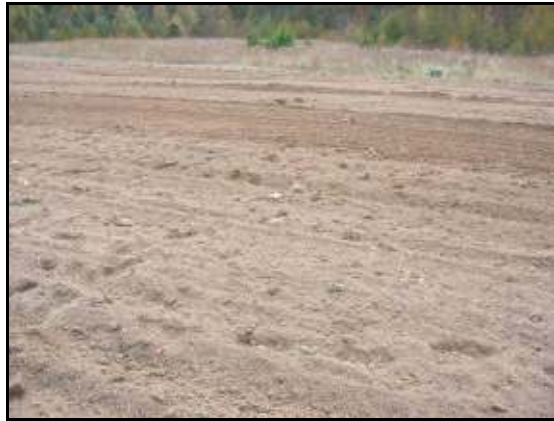
Figure 16. Field Ready for MCR Test

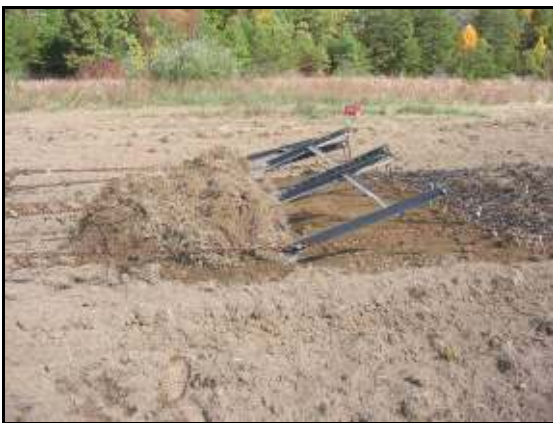
The MCR was towed through the test area by the Fendt Tractor at speeds varying from about 3 mph (5 kph) to 6 mph (10 kph). Regardless of the speed, a bow wave of dirt formed along the front edge of the rake (in front of the knives). (The higher speeds were tried to see if the dirt would flow over the rake structure rather than build up into a bow wave. Very slow speeds, 1 to 1.5 mph (1.4 to 2.5 kph), were tried but only resulted in the rake portion of the MCR coming totally out of the ground.) Smaller buildups of dirt formed in front of the front tow bar, the rear drag bar, and at various spots under the drag mat. The drag caused by the MCR's buildup of dirt required that the tractor be operated in 4-wheel drive. Maximum dirt buildup was achieved within 3-4 MCR lengths from start of towing. The bow wave in front of the knives achieved a height that consistently measured $\sim 19\frac{1}{2}$ inches (49.5 cm) at which point the dirt cascaded down the backside of the wave and was processed by the agricultural drag mat. The amount and weight of the dirt accumulated in front of the knives was so great that the easiest way to clean the MCR, thus allowing a fresh restart of the test, was with the assistance of a front end loader. When it was observed that the bow wave of dirt caused the knives to come out of the ground, the tow chain attachment points were moved back to the second set of attachment holes. However, the knives still came out of the ground. Pictures of the dirt buildup in the MCR and the knives out-of-the-ground are shown in Figures 17 and 18.

Figure 17. MCR Bow Wave

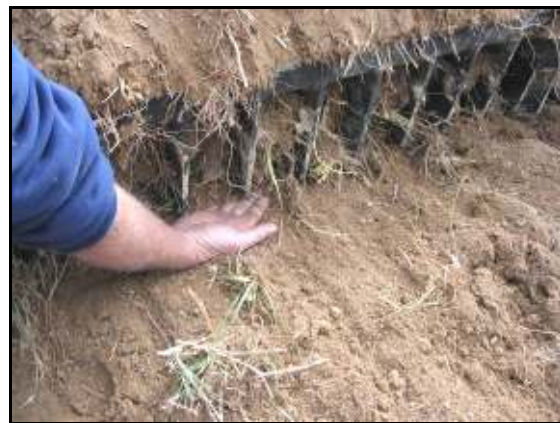
Figure 18. Knives out of the Ground

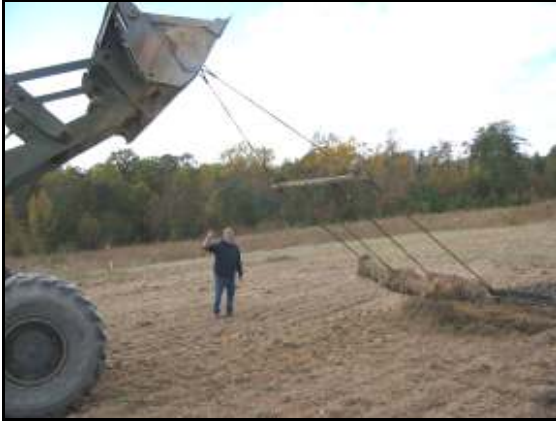
To clean the MCR, the towing ring of the MCR was removed from the Fendt tractor and looped over one of the teeth of a standard digging bucket attached to an Army front end loader. The bucket was then raised to pull the rake clear of the dirt bow wave

and the front end loader was backed away so that the MCR could be pulled out of and away from the debris heap. After the rake was cleared from the heap, people manually cleaned any remaining grass or roots from the tines and detached the MCR from the front end loader. The procedures used to clean the rake involve, at a minimum, two personnel (equipment operator and person on foot to attach/detach/clean the MCR) and a front loader. In this test, three personnel were used to clean the MCR (Fendt operator, front loader operator, attach/detach personnel), taking a total of 5min, 40 sec to complete the cleaning process. Pictures of the movement of the MCR by the front end loader and the manual cleaning of the rake are presented in Figures 19 and 20.

Figure 19. Clearing the MCR

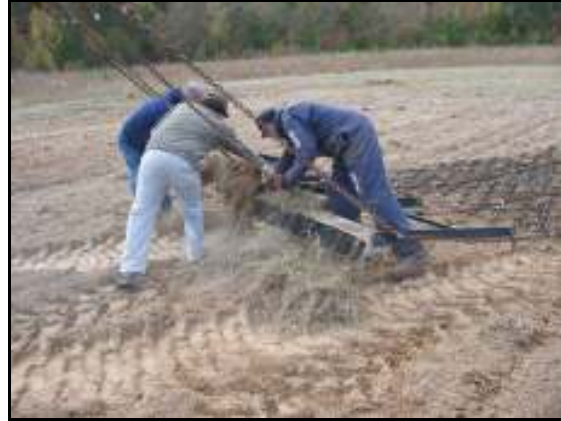
Figure 20. Cleaning the MCR

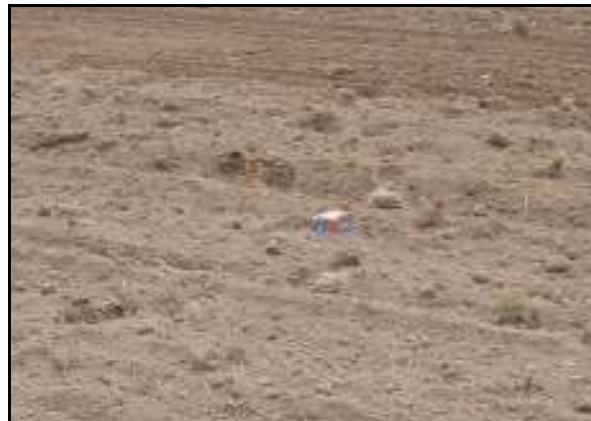
After testing the MCR on buried mines, a test of surface-laid anti-personnel mines was performed within the Test Site 1 field. Two mines were laid on top of the prepared field and within the path of the MCR, cleaned of debris prior to this test. The mines were placed at a point 40m and at 50m from the start of the MCR run. Figure 21 shows the condition of the field and the placement of the mines in the field.

Figure 21. Surface-Laid Mine

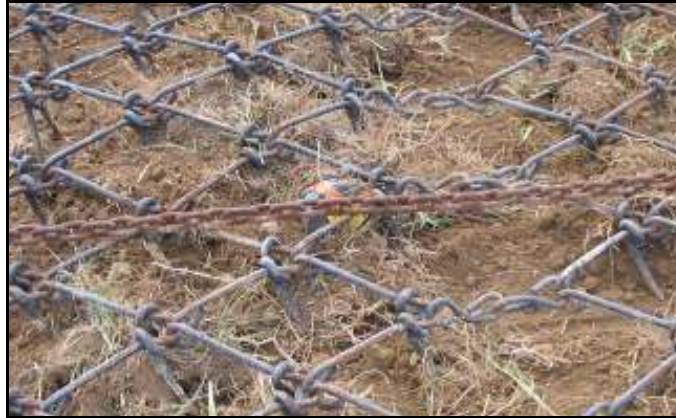
As the tractor and MCR passed over the mines, one mine was covered with dirt by the MCR and the other remained in place as the MCR drag mat moved across the top of the mine. The mine that remained in place was captured by photograph as the drag mat crossed over the top, as shown in Figure 22.

Figure 22. Surface-Laid Mine Remaining on Ground

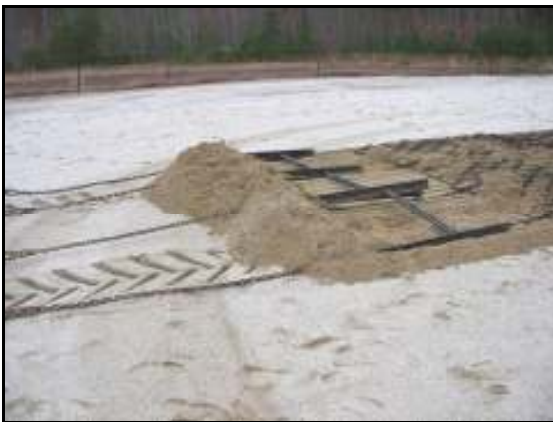
As in Test 1, the MCR was towed through the sand area by the Fendt Tractor at speeds varying from 3 to 5 mph (5 to 8.3 kph). Sand accumulated along the front edge of the digging tines, in locations under the drag mat during MCR movement, and in front of the rear drag bar. When the MCR reached the end of the test area, the bow wave in front had reached a height of 19in (48.2 cm) along the front of the digging tines. This accumulation prevented the tines, 17.8 cm in length, from fully penetrating the ground. The maximum digging depth of the tines by the end of the test run was measured to be 7.6 cm. Pictures of the sand accumulation are shown in Figures 23 and 24.

Figure 23. Accumulation at the Digging Tines

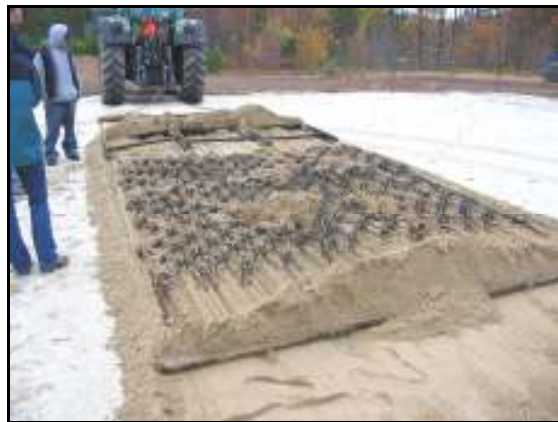
Figure 24. Accumulation within the Drag Mat

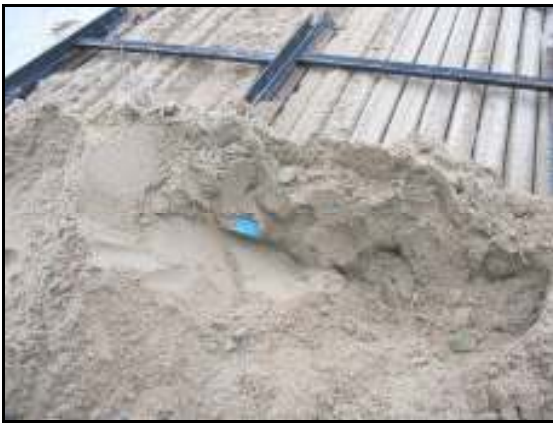
After one pass of the MCR, the field and the MCR accumulation mounds were closely examined for mines. This investigation found seven mines within the accumulation in front of the digging knives, one under the drag mat, one mine slightly exposed in its original location, and the last mine buried in its original location. Of the seven mines found within the sand accumulation in front of the digging knives, none were visible by the tractor operator during or after the test. The locations of these mines were not discovered until the buildups in front of the digging knives and within the drag mat were shoveled away. The final orientation of the mines within the front buildup varied from their original (burial) orientations indicating that they had been tumbled and rolled within the sand. Pictures of the mines discovered within the MCR sand accumulation are shown in Figures 25, 26, and 27.

Figure 25. Mine Found in Accumulation Heap

Only one mine was exposed, but not moved or brought to the surface by the MCR during the sand soil test. When the sand buildup in front of the digging knives array was shoveled away, seven of the mines were found buried in the sand against the front edges of the digging knives and one was found buried in the sand accumulation under the drag mat. An analysis of the location of where the mines were found showed that once the mines were engaged by the rake-portion of the MCR, the mines were pushed along in front of the rake rather than flowing up the front of the knives and being deposited on the surface. The distance from the point of burial to where the sand buildup was removed by shovel was 145 feet (44 m). After the test, the last mine was uncovered with a shovel at its original burial position.

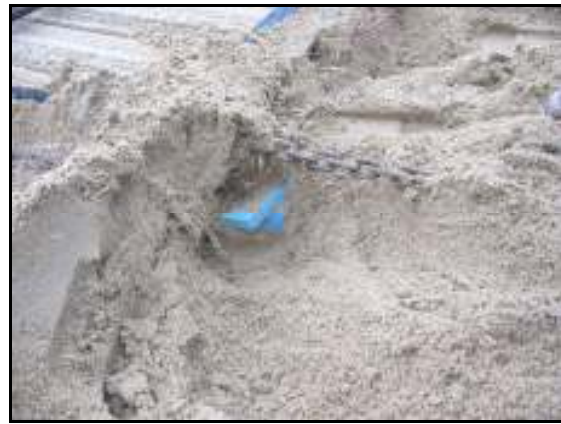
Figure 26. Two Mines Found Stacked within Accumulation Heap

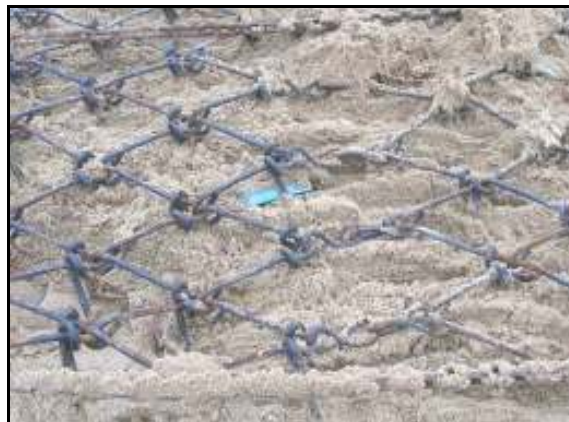
Figure27. Mine Found within Drag Mat Accumulation

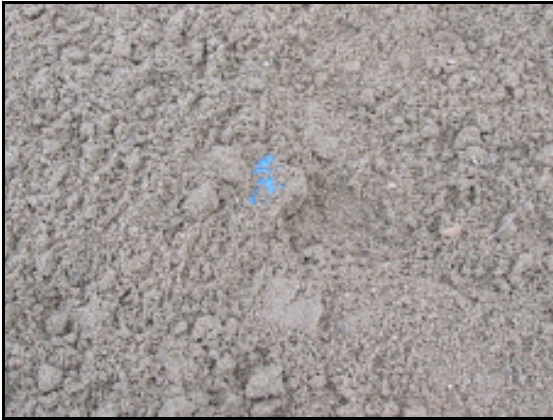
The remaining two mines were left in their original burial location. The uncovered mine was not shifted from its original burial location and was only visible due to its bright blue paint color and after close inspection of the area. The second mine

Figure 28. Exposed Mine in Original Location

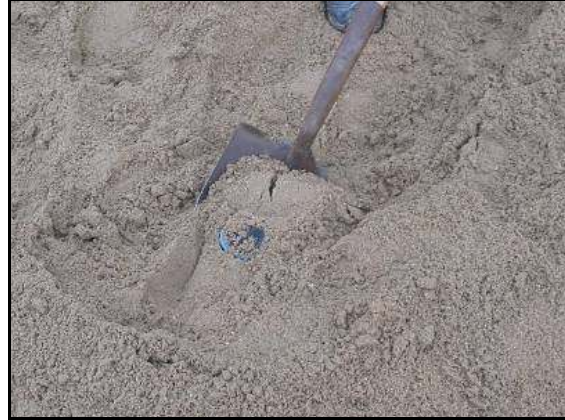
appeared untouched by the MCR and was uncovered by shovel after the test was complete. Pictures of these two mines are found in Figures 28 and 29.

Figure 29. Tenth Mine Found after Shoveling
